AMELIORATION OF ROOT ROT HAZARDS IN GRANITIC SOILS

George Borst

Soil scientist, Fallbrook, California.

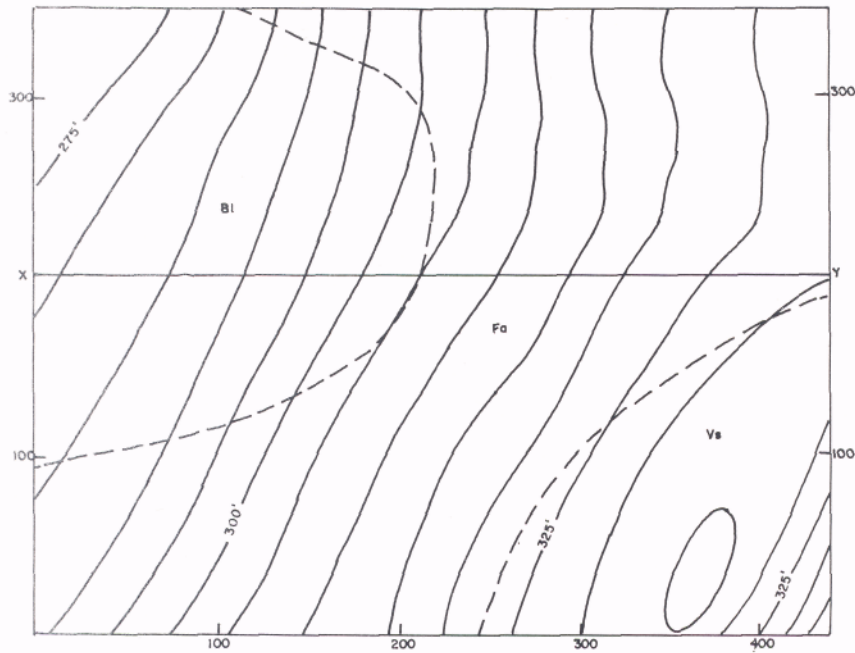
Figure 1. Topographic map of a portion of the project, showing a typical body of Bonsall soils in the upper left. Scale 1 inch=50 feet. Contour interval—5 feet. Soil boundaries shown as dashed lines. Soil symbols—Bl, Bonsall sandy loam—Fa, Fallbrook sandy loam—Vs, Vista coarse sandy loam.

In order to eliminate critical barriers to downward water movement, it was decided to completely remove the clay subsoils of the Bonsall soils, and to fracture the hardpans underlying the Bonsall and Fallbrook soils. After an initial discing, to remove the cover crop, additional soil borings were made, and the approximate boundaries of the Bonsall soils were identified and staked. The surface soil was then removed from the staked areas, and stockpiled to one side. This provided an opportunity to observe the precise limits of their clay subsoils, and establish their relationship to the surrounding soils.

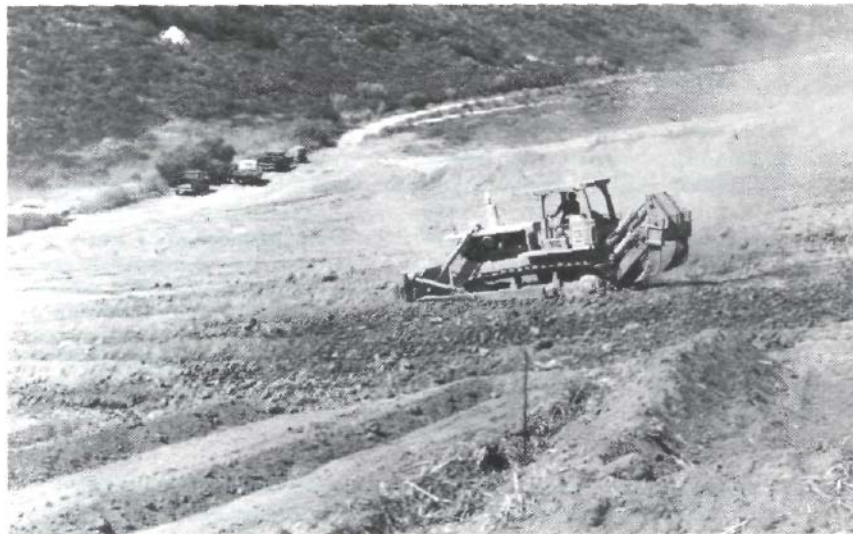
Figure 3. Tractor ripping subsoil of Bonsall sandy loam, after removal of topsoil, approximately along Line X-Y, Figure 1, preparatory to removal by scrapers. Stockpiled topsoil in foreground and beyond the ripped area.

These clay subsoils were then ripped and excavated, using a D-8 Caterpillar ripper-dozer and two large LeTourneau scrapers. This material was used as fill in a large barranca which bisected the proposed planting. A combination storm and subsurface tile drain was installed to remove surface and subsurface waters that might collect in the fill material in this barranca. The surface soil was then replaced in areas from which it had been removed, and the entire area ripped and cross-ripped to a depth of approximately 60 inches.
