California Agriculture. 1972. 26(7):12-14.

DRIP IRRIGATION EXPERIMENTS WITH AVOCADOS IN SAN DIEGO COUNTY

C. D. GUSTAFSON, A. W. MARSH, R. L. BRANSON and STERLING DAVIS

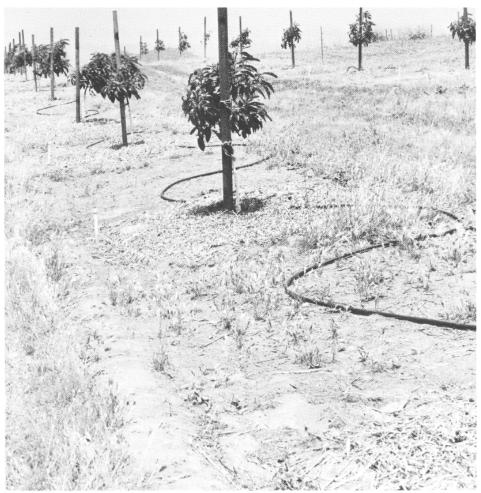
One of the blocks of Hass avocados being irrigated with the drip irrigation system. Also visible in photo is the installed, but as yet unused sprinkler irrigation system available if the drip irrigation system should fail.

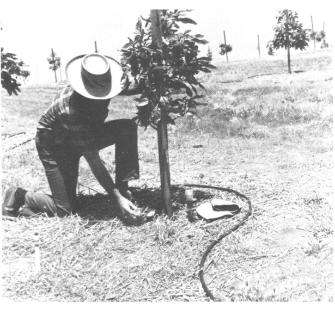
Tensionmeter location is shown with respect to the tree and the drip irrigation line.

The five-acre test plot was divided into eight blocks, four under drip irrigation and four under sprinklers. The two varieties, Hass and Reed, were evenly divided in each block. The 673 trees were planted 15 x 20 ft in blocks. Three hundred and forty nine trees were drip irrigated and 324 were sprinkled. Two tensiometer stations, each having instruments at 12 and 24-inch depths, were placed within each block. Initially the 12-

inch instruments were inserted into the balls of the newly planted trees.

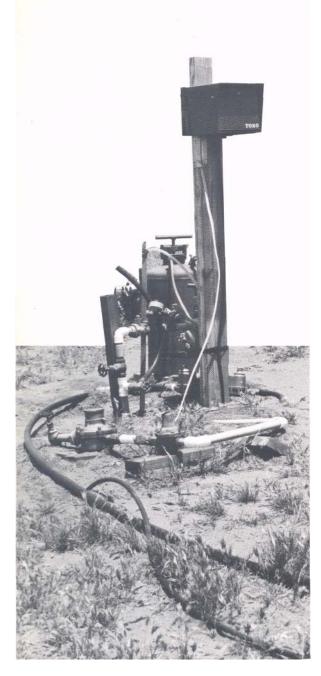
Water head showing fertilizer injector tank, various control valves, pressure regulating valve, water meter, and time clock control device for control of the drip irrigation system

The drip irrigation system includes a fertilizer tank, filter, water meter, irrigation controller, pressure regulator, pressure gauges, flexible hose for sub mains and laterals, and the emitters. The system operates at 15 pounds per square inch and each emitter discharges approximately one gallon per hour. Three emitters are placed at each tree—one near the trunk and the other two on either side 2 ft. away from the trunk.
